INDOOR AIR QUALITY REASSESSMENT

**John R. Briggs Elementary School
96 Williams Road
Ashburnham, Massachusetts**

Prepared by:
Massachusetts Department of Public Health
Center for Environmental Health Assessment
Emergency Response/Indoor Air Quality Program
April 2005

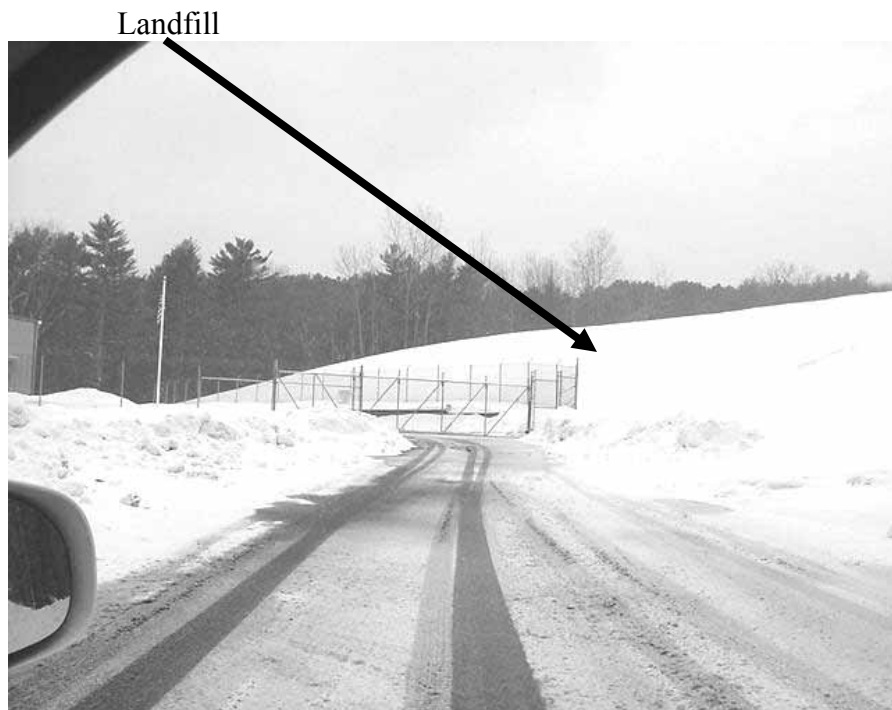
Picture 1

Concerns were also raised about possible groundwater contamination from a capped landfill located approximately one half mile north of the BES (Picture 1). A number of different conditions appear to make contaminated groundwater penetrating into the building unlikely:

Based on available information, it is unlikely that contaminated groundwater is penetrating into the interior of the building.

Capped Landfill One-Half Mile North of BES

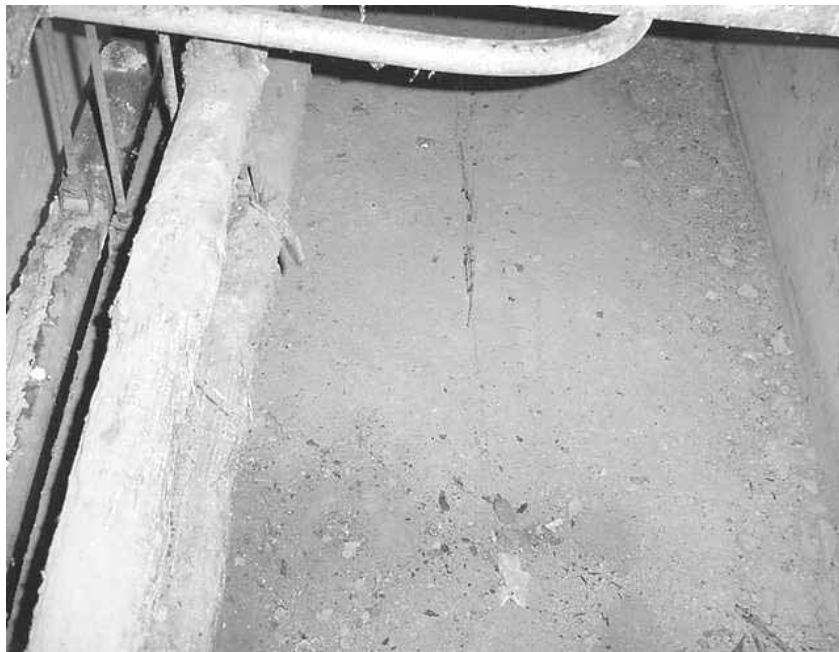
Picture 2

1. If any pollutants were present in local surface/groundwater, the most likely place for such materials to accumulate is in the lowest point of a building (in this case, the crawlspace). The crawlspace beneath the hallway classrooms closest to the capped landfill was examined, since it is the lowest point within the school structure. The crawlspace was found to be dry and free of any accumulated odors or moisture (Picture 2). In addition, air sampling results did not detect VOCs in the ambient air of classrooms nor in the crawlspace.

Crawlspace Free of Any Accumulated Odors or Moisture

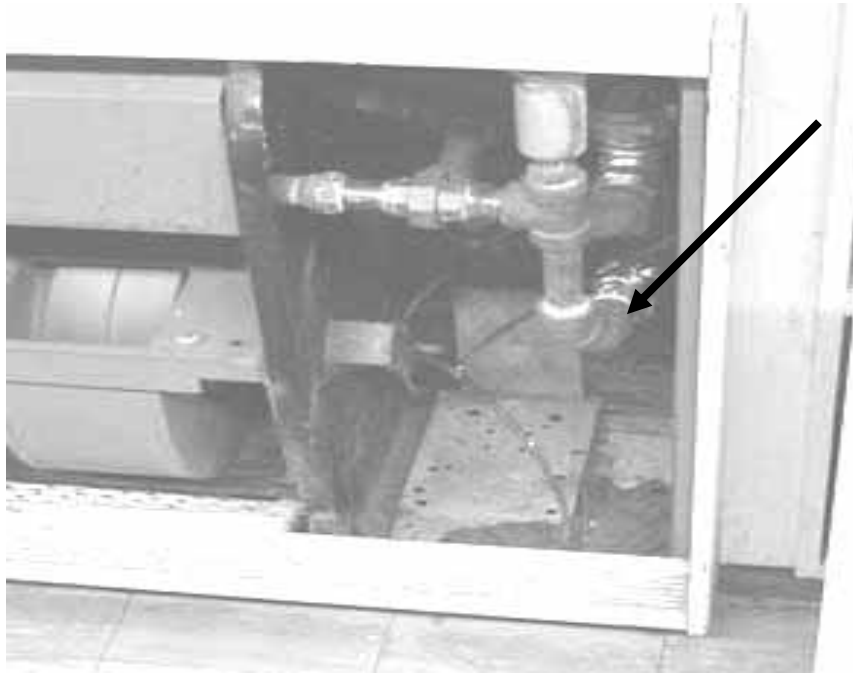
Picture 3

2. Ventilation/heating system components or electrical conduits are not located in the slab beneath classroom univents (Picture 3). The lack of penetrations through the floor under the univent eliminates a pathway for potential odors to enter classrooms.

**Univent Floor Is Solid Without Holes/Penetrations
(Note Pipe Curving Towards Rear of Cabinet)**

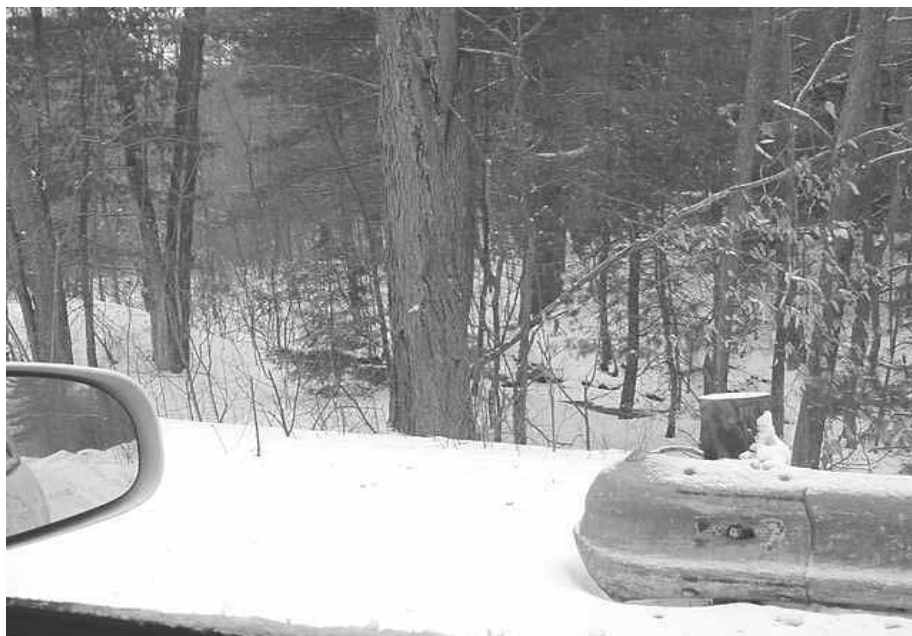
Picture 4

3. The BES and the capped landfill are located on the opposite sides of a glen formed by an unnamed brook that passes beneath Williams Road (Map 1, Picture 4). The school is elevated above the level of the brook on a slope formed by hills to the

south/southwest. Groundwater flooding in the crawlspace was not been reported as a reoccurring problem, nor were signs of flooding present in the crawlspace, which eliminates groundwater contamination as a potential odor source.

Unnamed Brook that Crosses North of BES

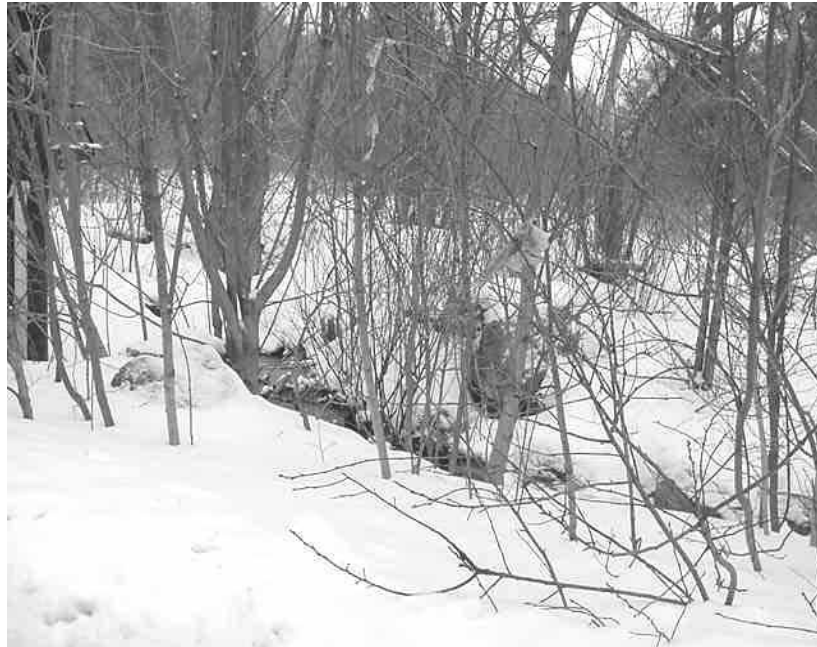
Picture 5

4. An examination of topographical maps of the area indicate that surface water in the general area would be expected to flow in the same direction and the unnamed brook, an easterly direction *away* from the BES to wetlands located north of Platts Road. (Maps 2 and 3). The wetlands serve as a tributary to the Whitman River, which flows in an southeasterly direction. Therefore, if pollutants were escaping from the landfill, the direction of surface/groundwater flow should carry the contamination in an easterly direction, away from the grounds of the BES.
5. A second body of water exists between the BES and the capped landfill. This stream run along Turnpike and meets the northwest corner of the intersection of Turnpike and Williams Roads (Picture 5). This stream appears to be created by Turnpike Road, which serves as a natural barrier to water from the north.

Unnamed Stream at Northwest Corner of the Intersection of Turnpike and Williams Roads

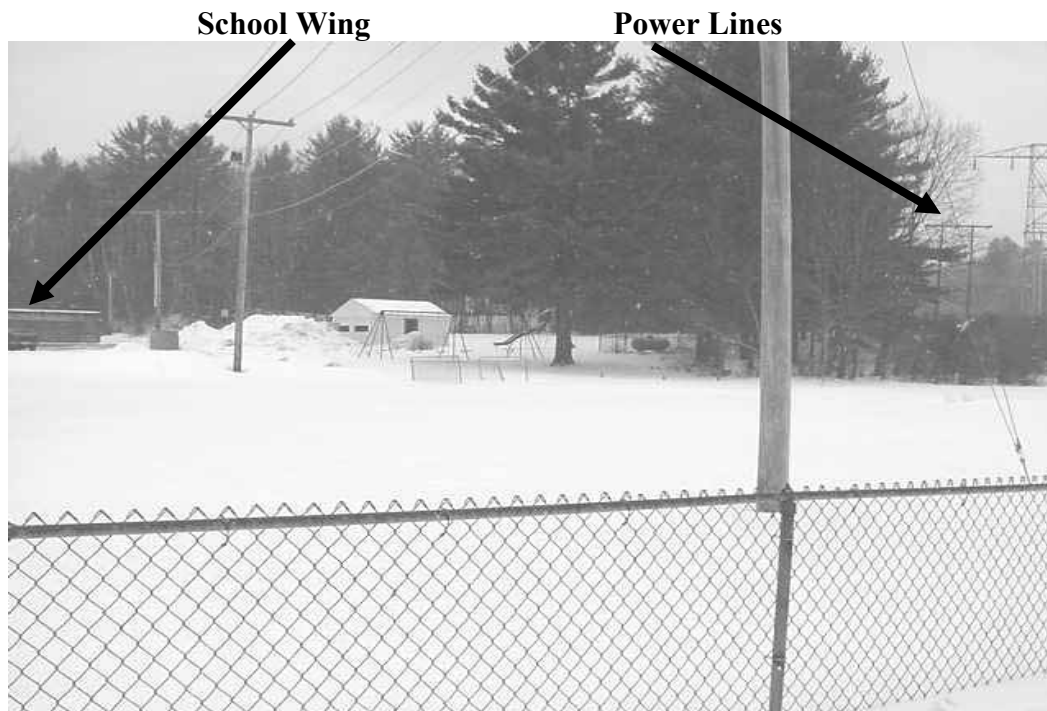
Picture 6

Parents also expressed concern about electrical power transmission lines that were located in a right-of-way north of the BES (Picture 6). Electrical power transmission lines are a source of electrical and magnetic fields (EMFs); however, the fields tend to drop off after 200 feet (MDPH, 1993). MDPH staff estimate that the electric power transmission lines are located over 330 feet from the closest point of the exterior wall of the BES. Therefore, EMFs from the electrical power lines on the indoor environment are unlikely to impact the health of building occupants.

Electrical Power Transmission Lines That Were Located In a Right-Of-Way North Of the BES
